Debris/Ice/TPS Assessment And Integrated Photographic Analysis For Shuttle Mission STS-49

July 1992

Gregory N. Katnik
NASA/Kennedy Space Center

OV-105 Endeavour (1st flight), ET-43 (LWT 36), BI-050 SRBs

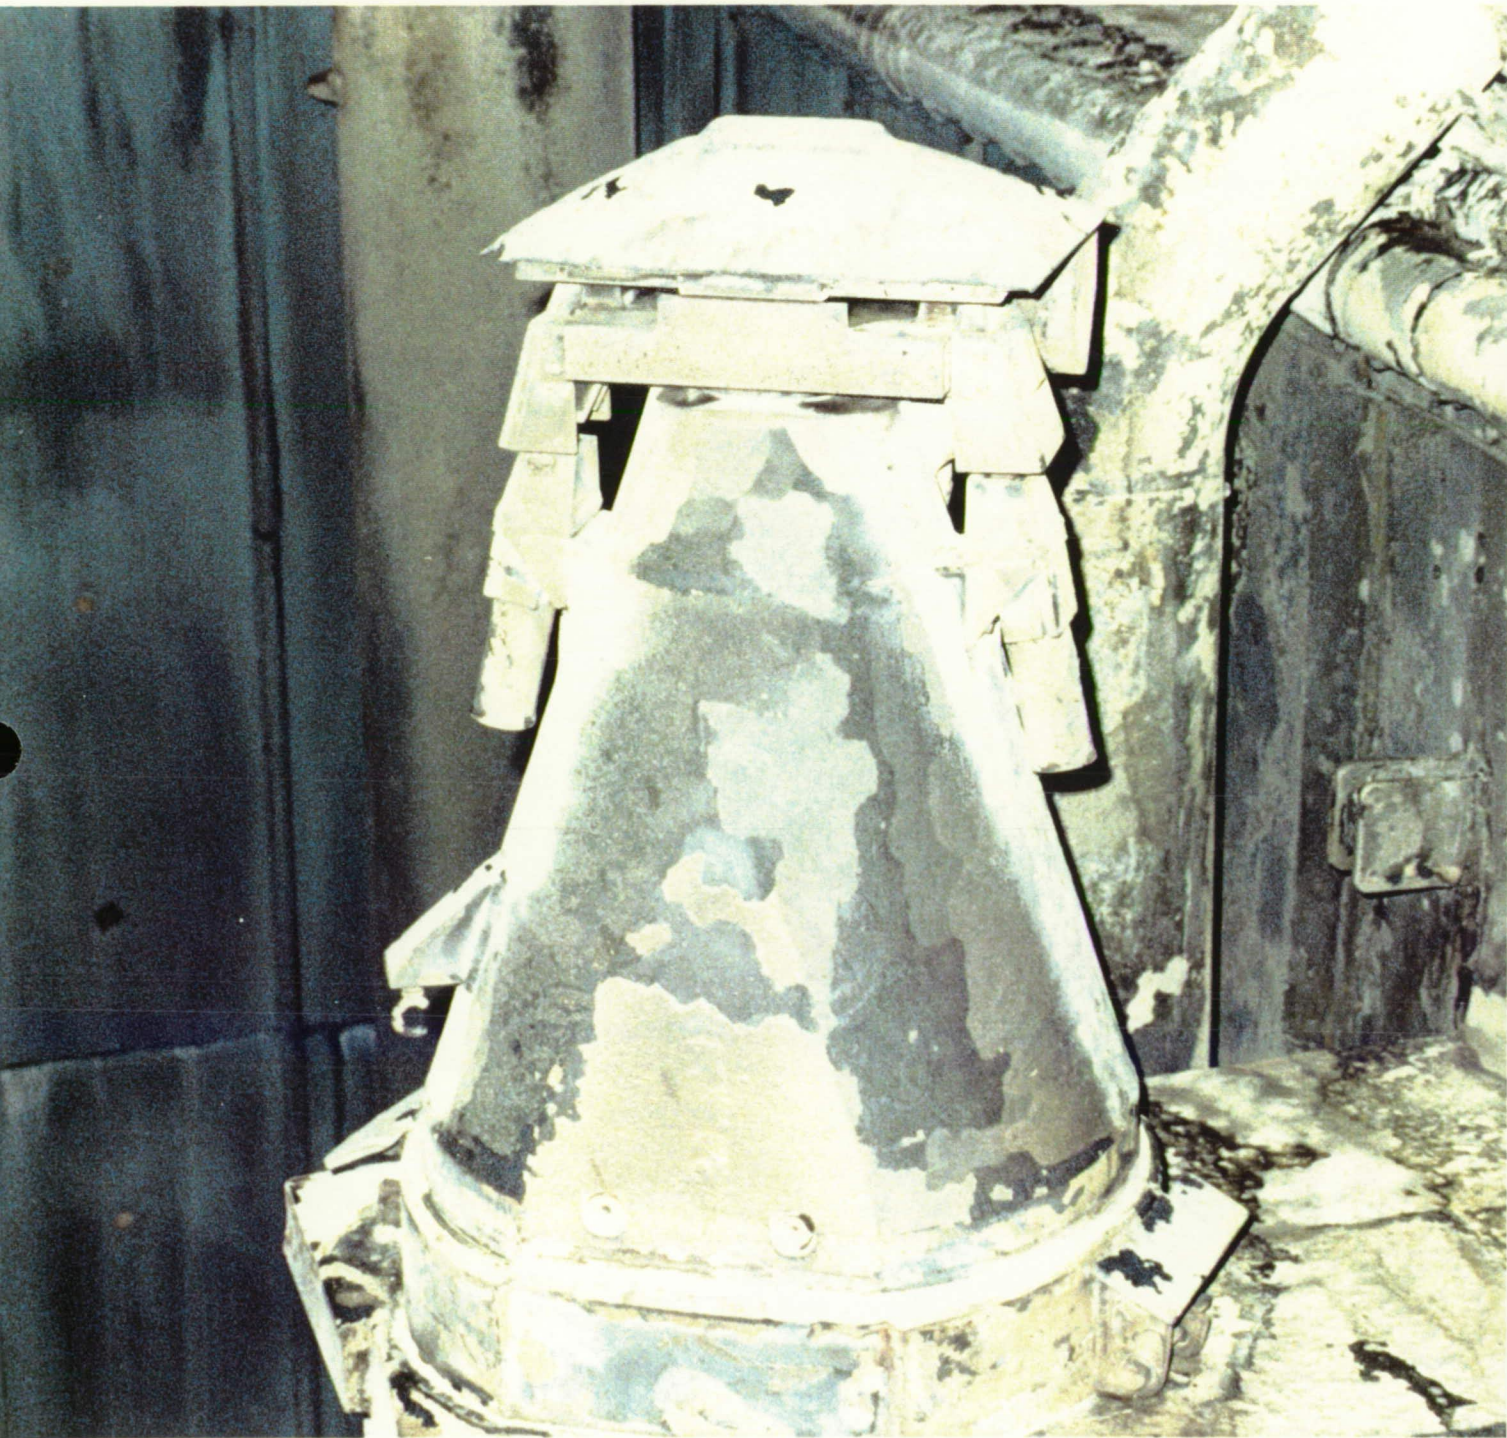
North HDP blast covers were in the closed position and exhibited typical SRB plume erosion effects with some loss of material at the corners.

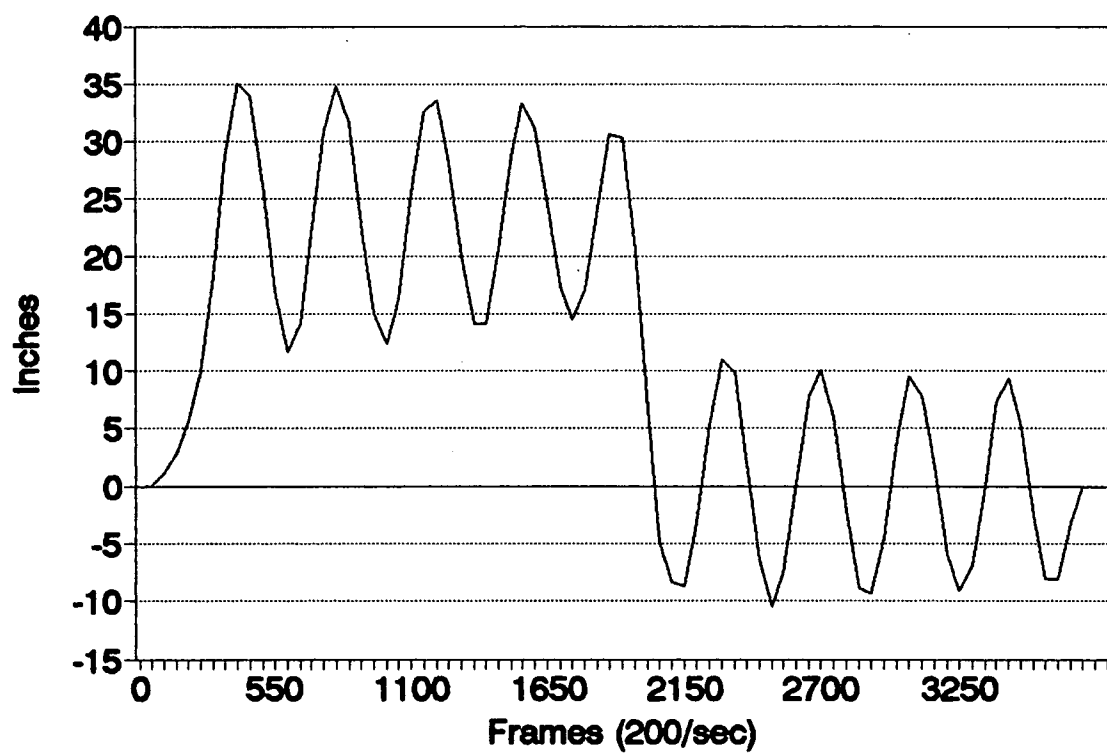
Figure 6. **ET Tip Deflection**
STS-49 FRF

caused the vehicle to oscillate between the plus 10-inch and minus 10-inch marks. Total excursion of the ET spike during the FRF was 45 inches (Reference Figure 6).

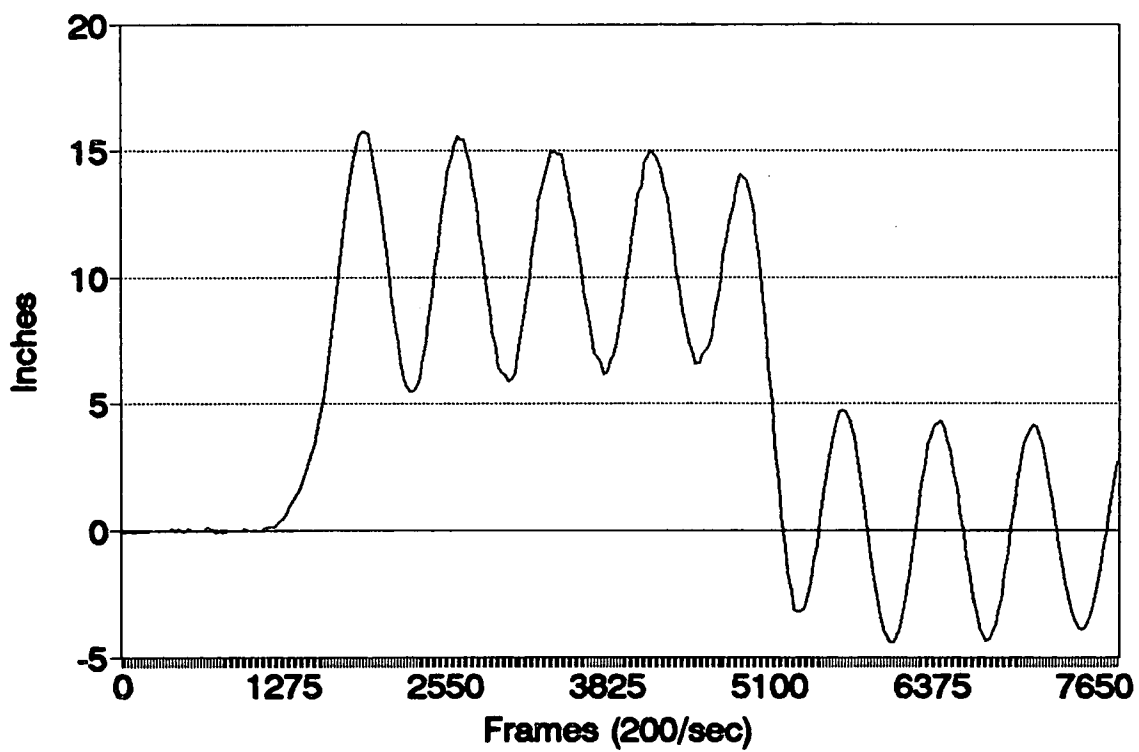
Figure 7. **LH2 Gucp Deflection**
STS-49 FRF

Excursion of the ET at the GUCP followed a similar pattern, but with smaller amplitudes, to the nosecone deflection (reference Figure 7).

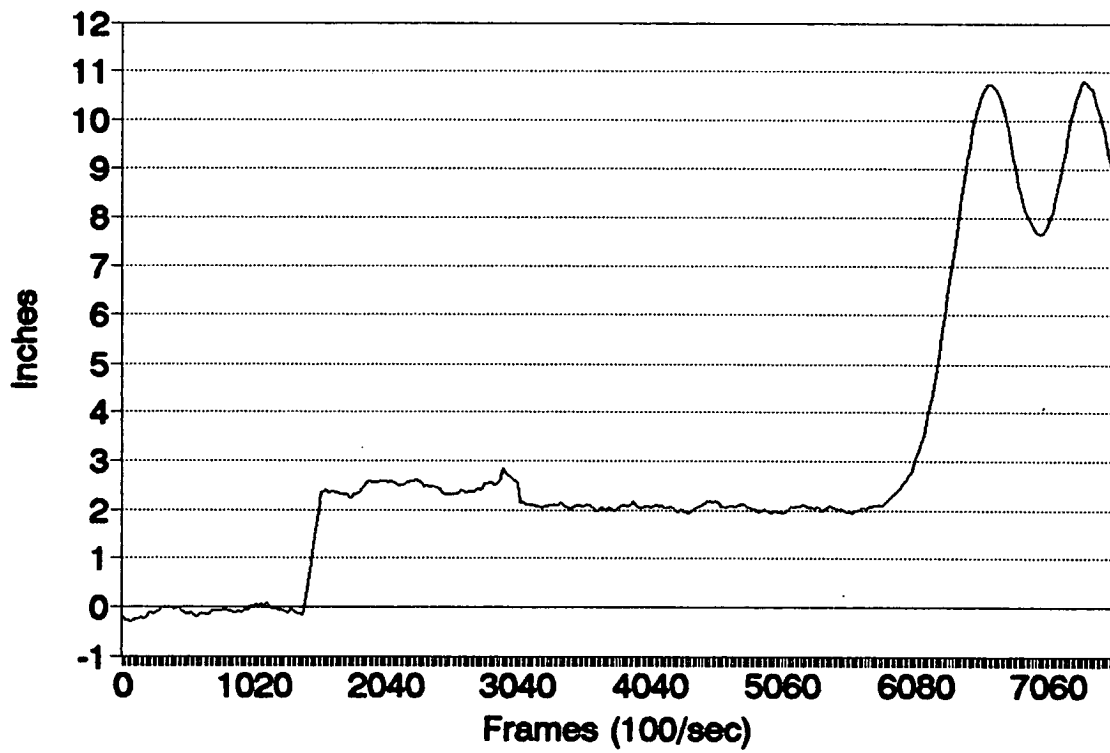
Figure 8.

The TSM LO2 T-0 umbilical had been instrumented with position measuring devices to measure the umbilical excursion during cryoload and FRF. Data obtained from the devices and from film item E-21 as measured on the S.F.A.T. film analyzer, showed the umbilical had moved downward during slow fill a maximum of 0.44 inches due to the weight of the ET cryogenics. By the end of slow fill, the ET was contracting from the low temperatures, which caused an upward movement. Upon completion of LH2 fast fill, the umbilical had moved upward a maximum of 2.75 inches above the initial pre-cryoload position. Firing of the SSME's during the FRF caused the umbilical to move upward an additional 9 inches reaching a maximum excursion of 10.7 inches (reference Figure 8).

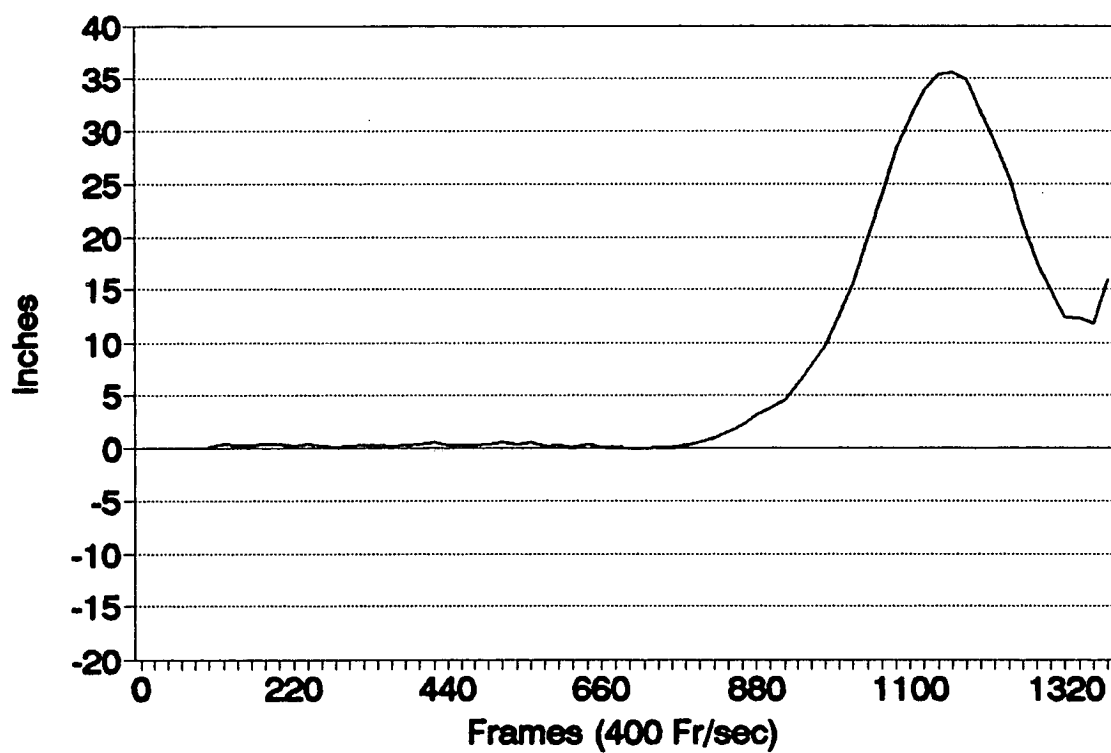
Figure 9. **ET Tip Deflection**
STS-49

ET nosecone deflection, as measured from film item E-79 on the S.F.A.T. film analyzer, was 35 inches at the greatest deflection from the "zero" start position. The vehicle returned to the 12-inch mark before launch (reference Figure 10).

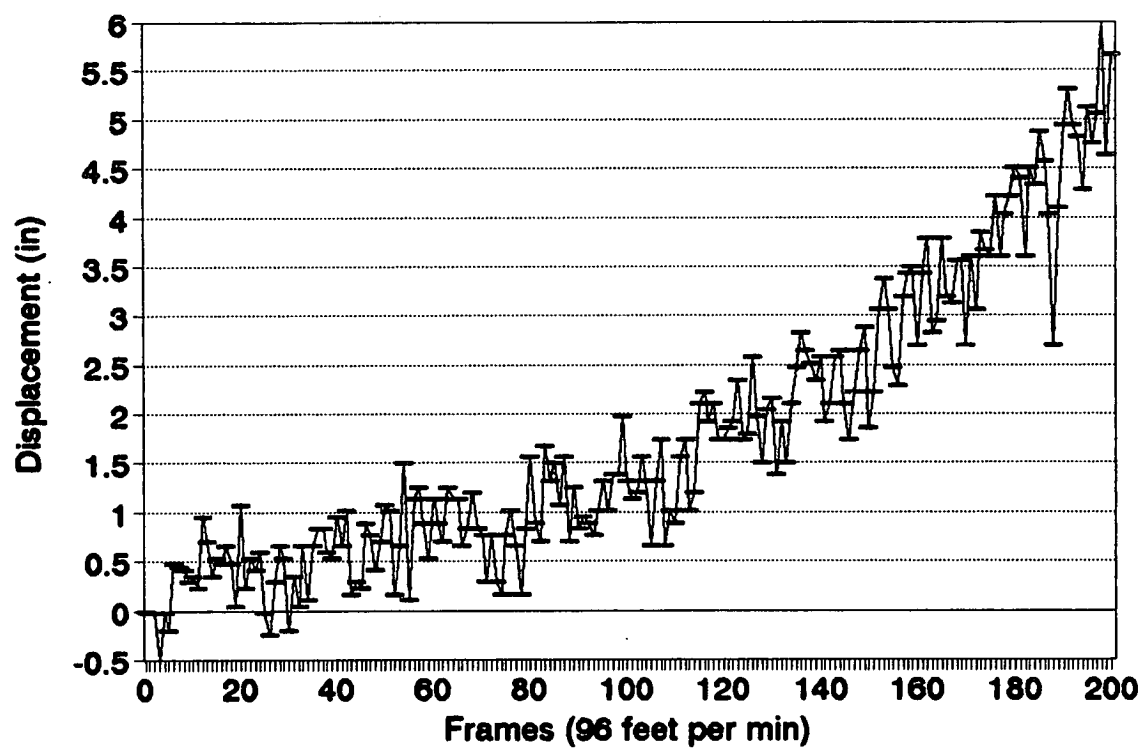
Figure 10

Film items E-76, 77, 19, 20 again showed a fore-and-aft movement of the Orbiter base heat shield in the centerline area between the SSME cluster during engine start-up. The movement subsided as the SSME plume stabilized and the Mach diamonds formed. Measurements of E-76 on the film analyzer showed the amplitude was 1.1 inches (reference Figure 9).

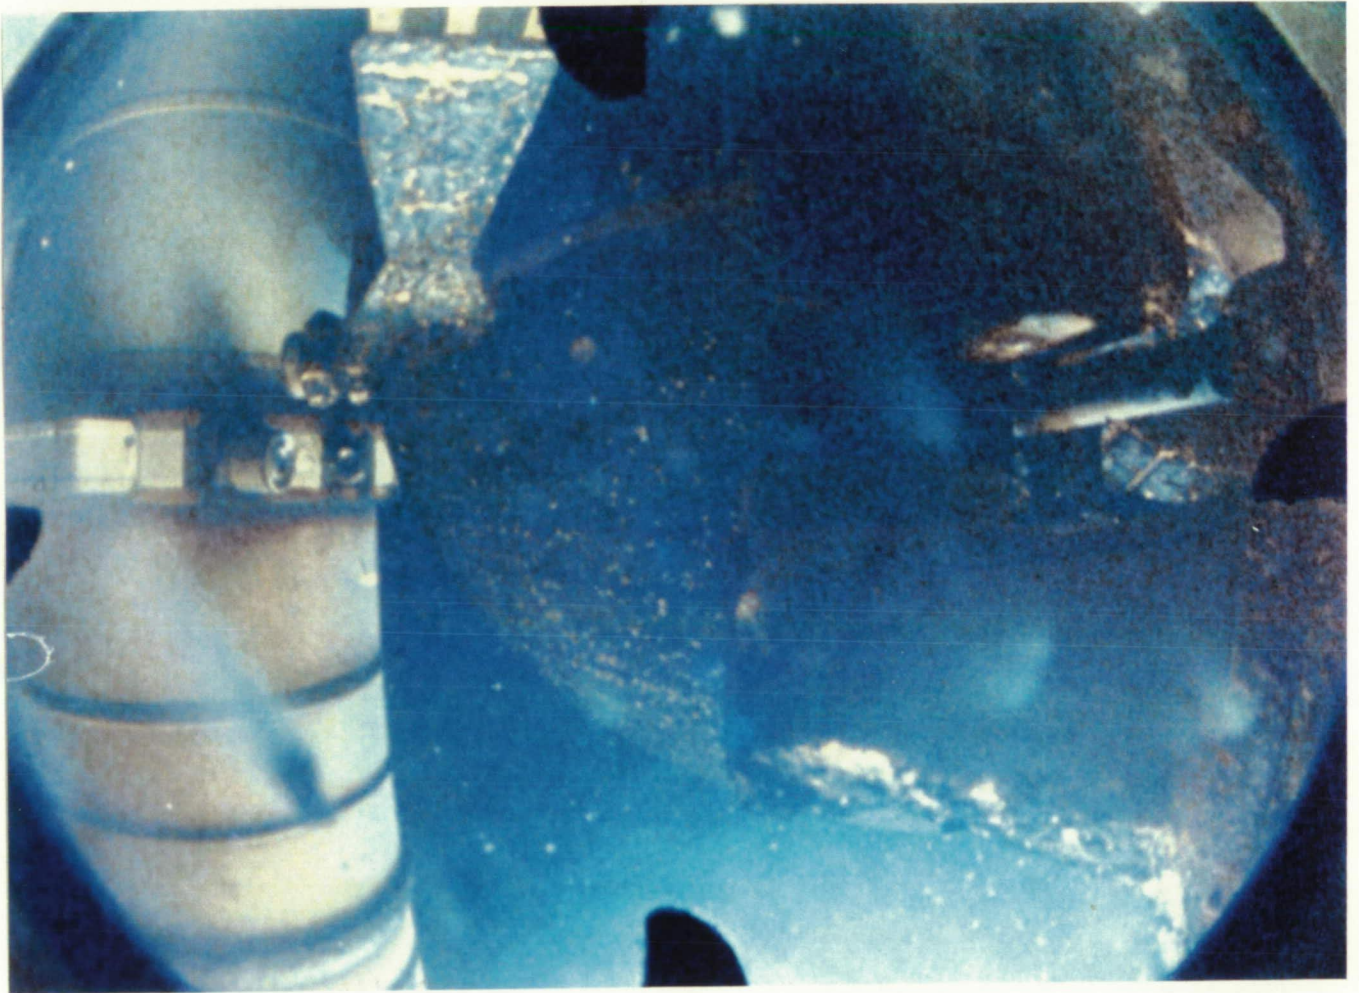
LH2 ET/ORB umbilical separation camera showed typical erosion and charring of TPS on the aft surfaces of the umbilical cable tray and -Y vertical strut. Plume recirculation and aft dome heating caused the usual charring and "popcorning" of the NCFI foam.

LH2 ET/ORB umbilical separation camera showed no vehicle damage or loss of flight hardware that would have been a safety of flight concern. Separation of the LH SRB from the External Tank was normal. No loss of TPS from the upper strut fairing was visible.

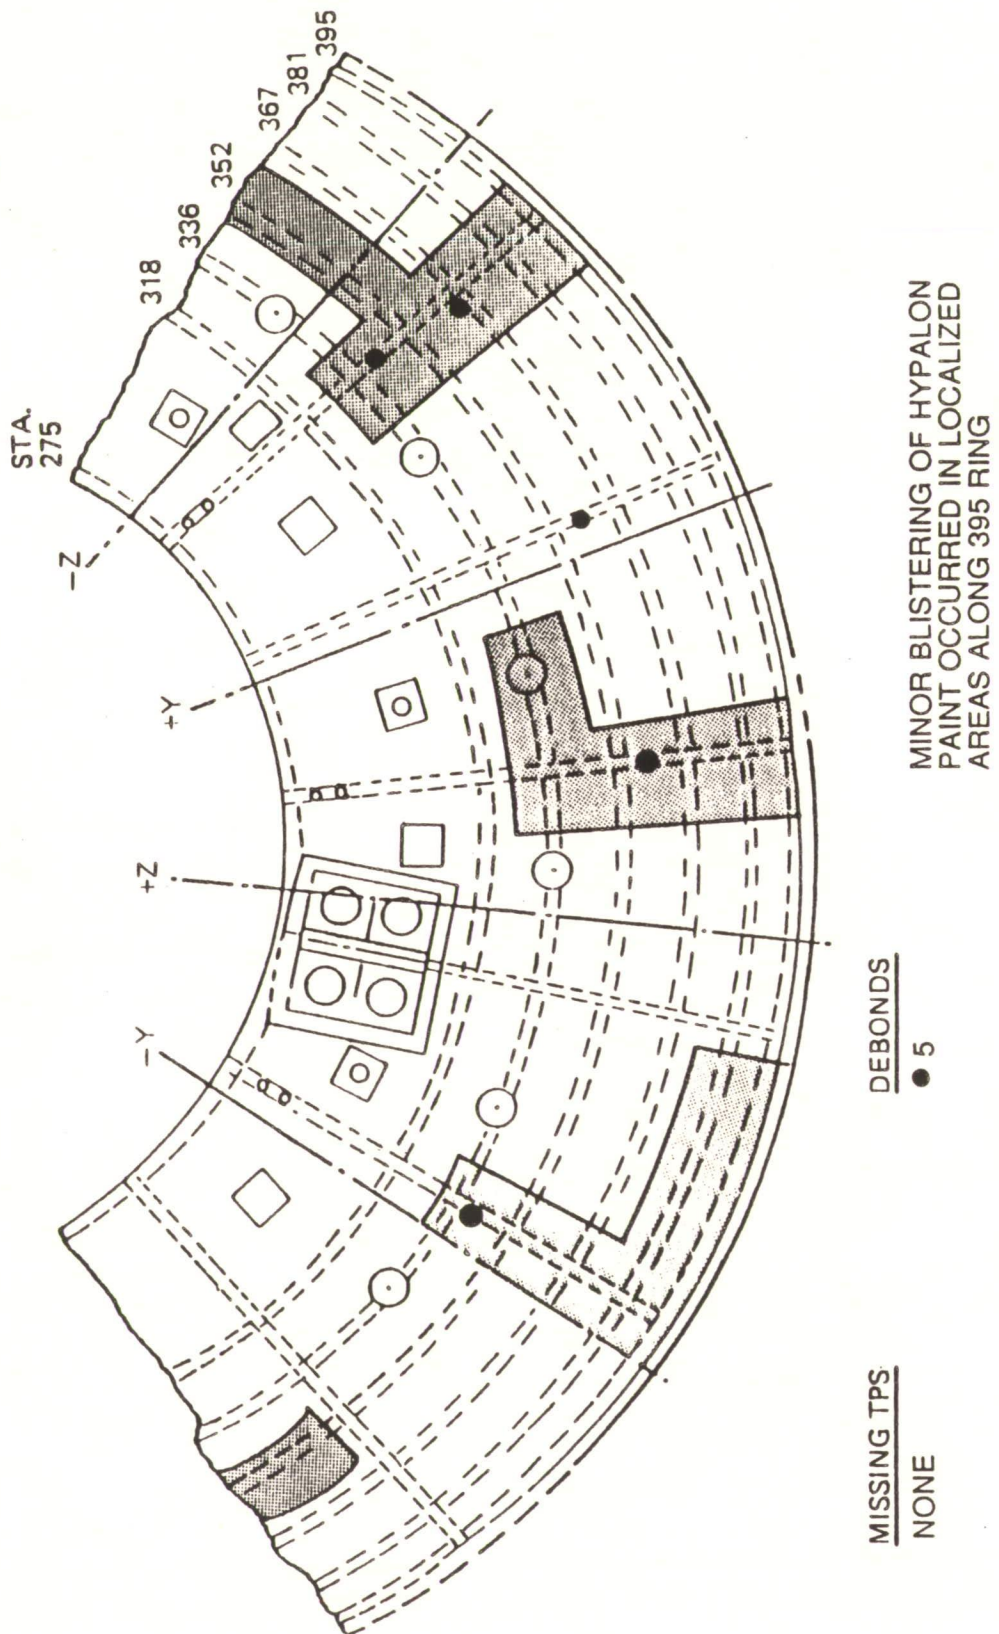
Figure 11. RIGHT SRB FRUSTUM

The RH frustum was missing no TPS but had 5 MSA-2 debonds over fasteners (Figure 11). Minor blistering of the Hypalon paint had occurred along the 395 ring. All BSM aero heatshield covers were locked in the fully opened position. However, two (right side) cover attach rings had been bent at the hinge by parachute riser entanglement.

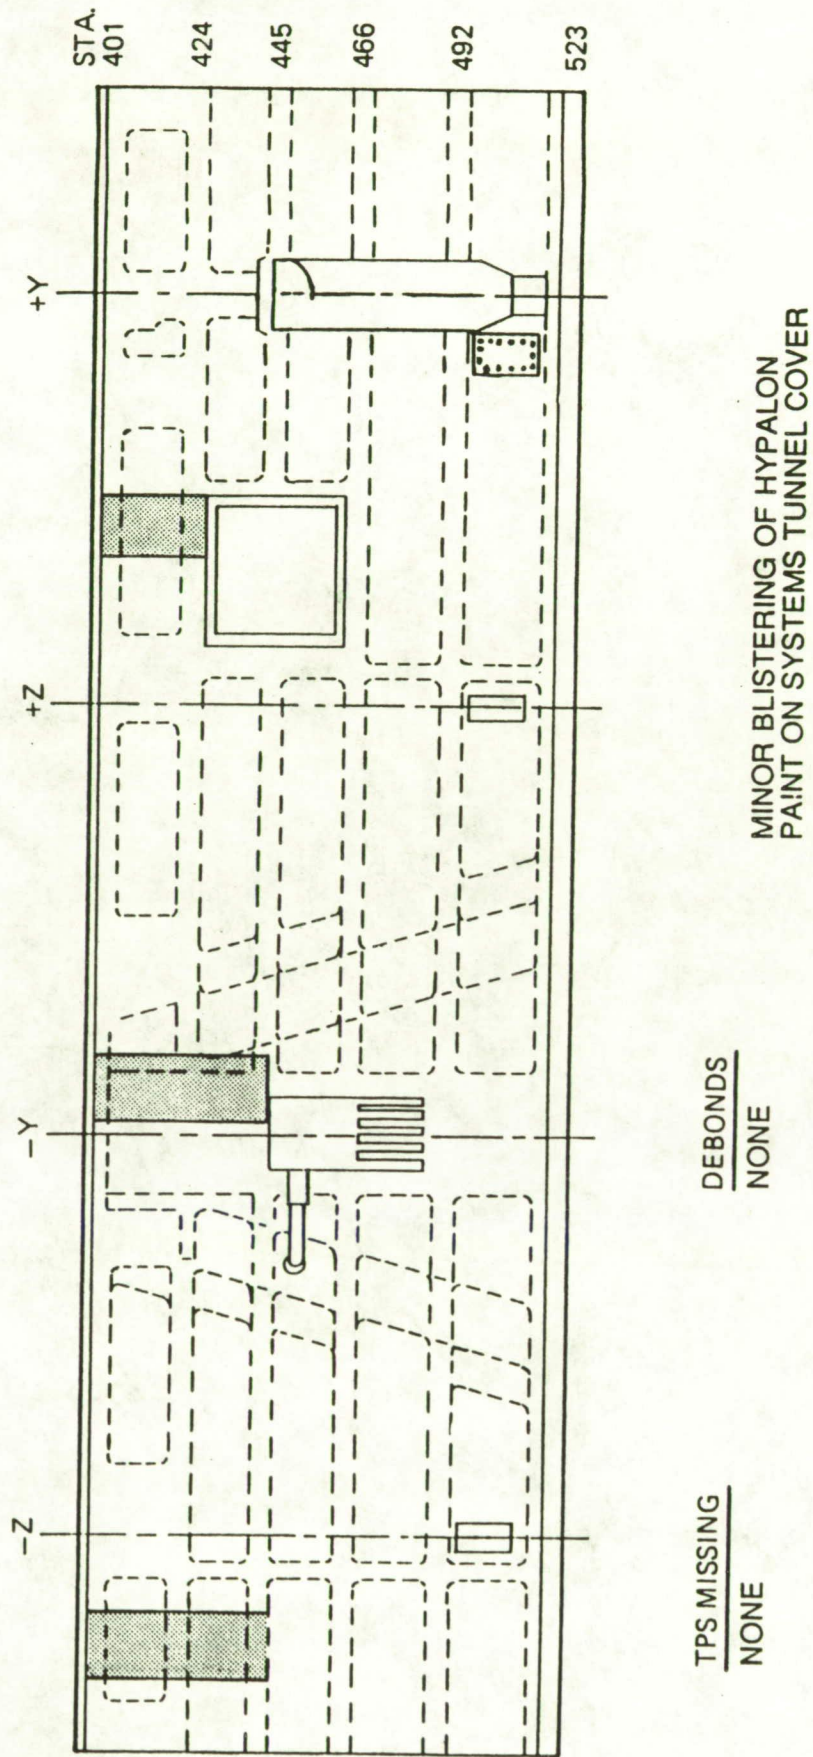
Figure 12. RIGHT SRB FWD SKIRT

The RH forward skirt exhibited no debonds or missing TPS (Figure 12). The phenolic plates on both RSS antennae were intact. Minor blistering of the Hypalon paint occurred on the systems tunnel cover and around the forward attach point. The forward separation bolt and electrical cables appeared to have separated cleanly. No pins were missing from the frustum severance ring.

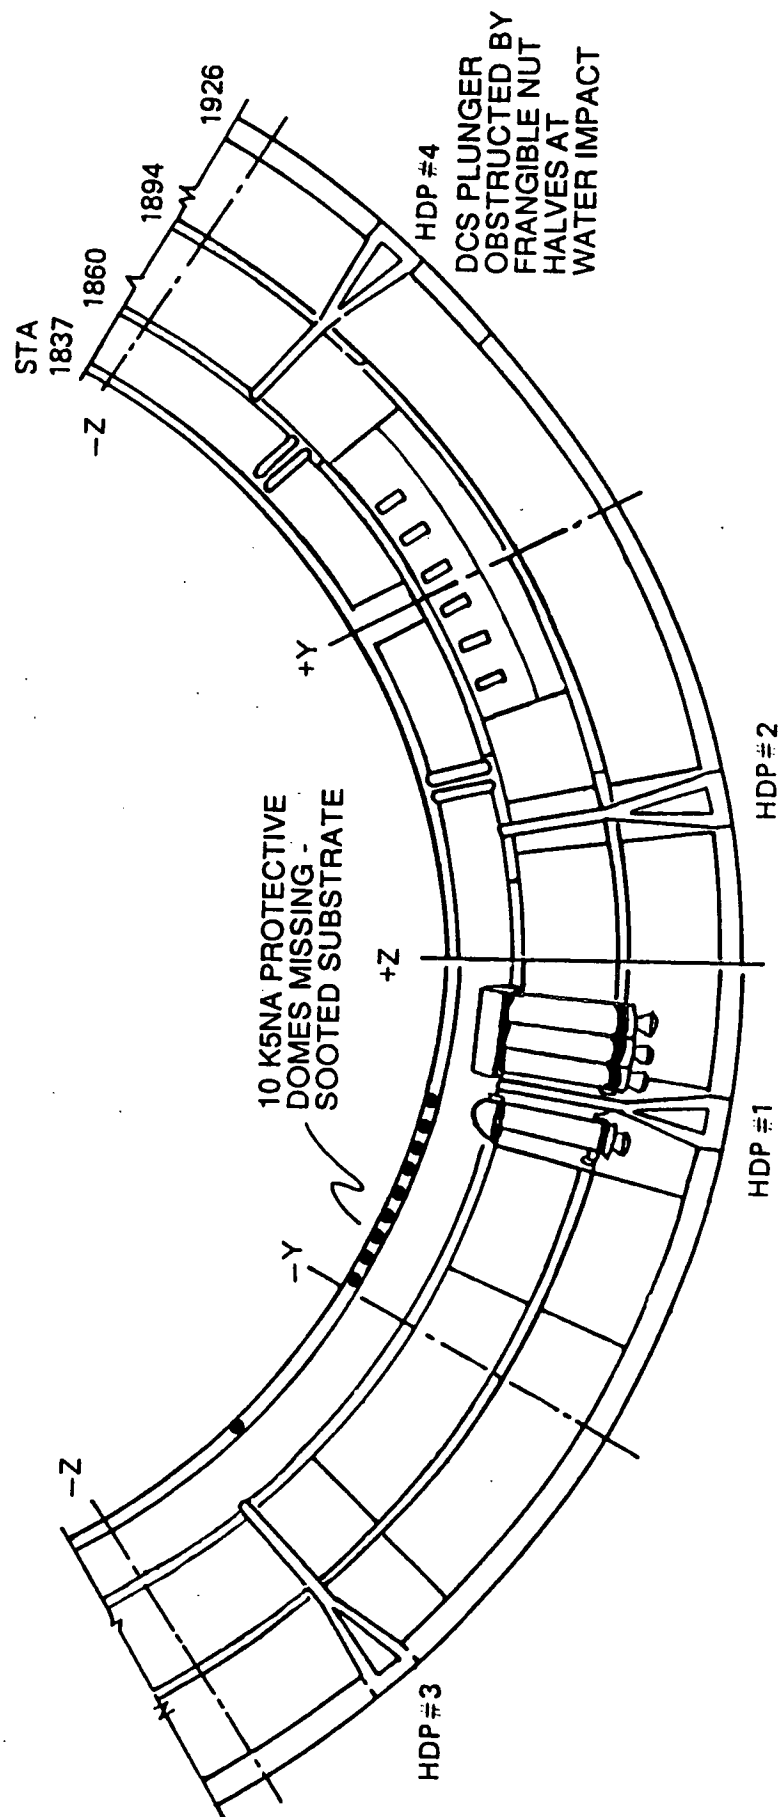
Figure 13. **RIGHT SRB AFT SKIRT EXTERIOR TPS**

The phenolic material on the kick ring had delaminated. Ten K5NA protective domes were lost from bolt heads on the aft side of the phenolic kick ring prior to water impact (sooted substrate). The aft skirt acreage TPS was generally in good condition (Figure 13).

All Debris Containment System (DCS) plungers were seated properly with the exception of HDP #4, which was obstructed by frangible nut halves. This was the seventh flight utilizing the optimized link. None of the EPON shim material was lost during ascent.

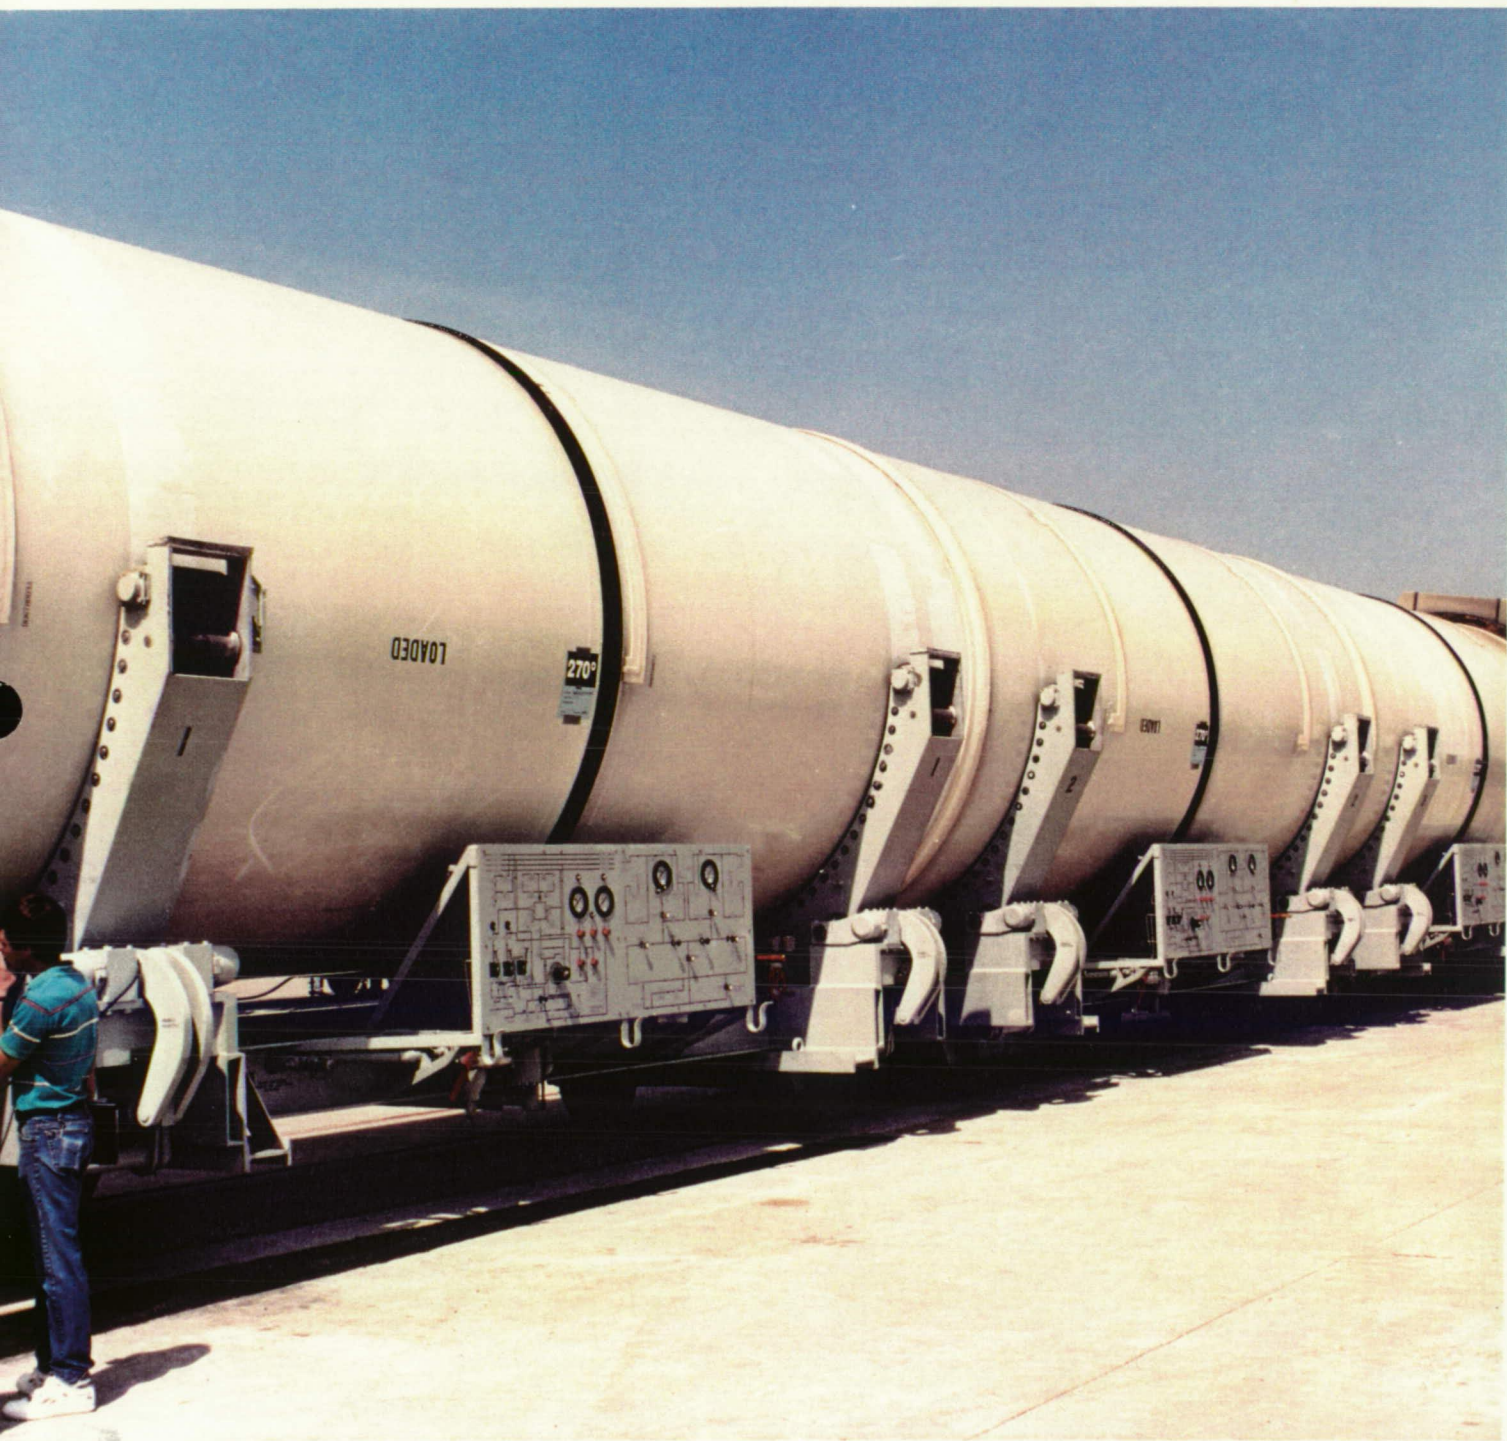
SRM segment cases, Field Joint Protection System (FJPS), and GEI cork run closeouts were in good condition.

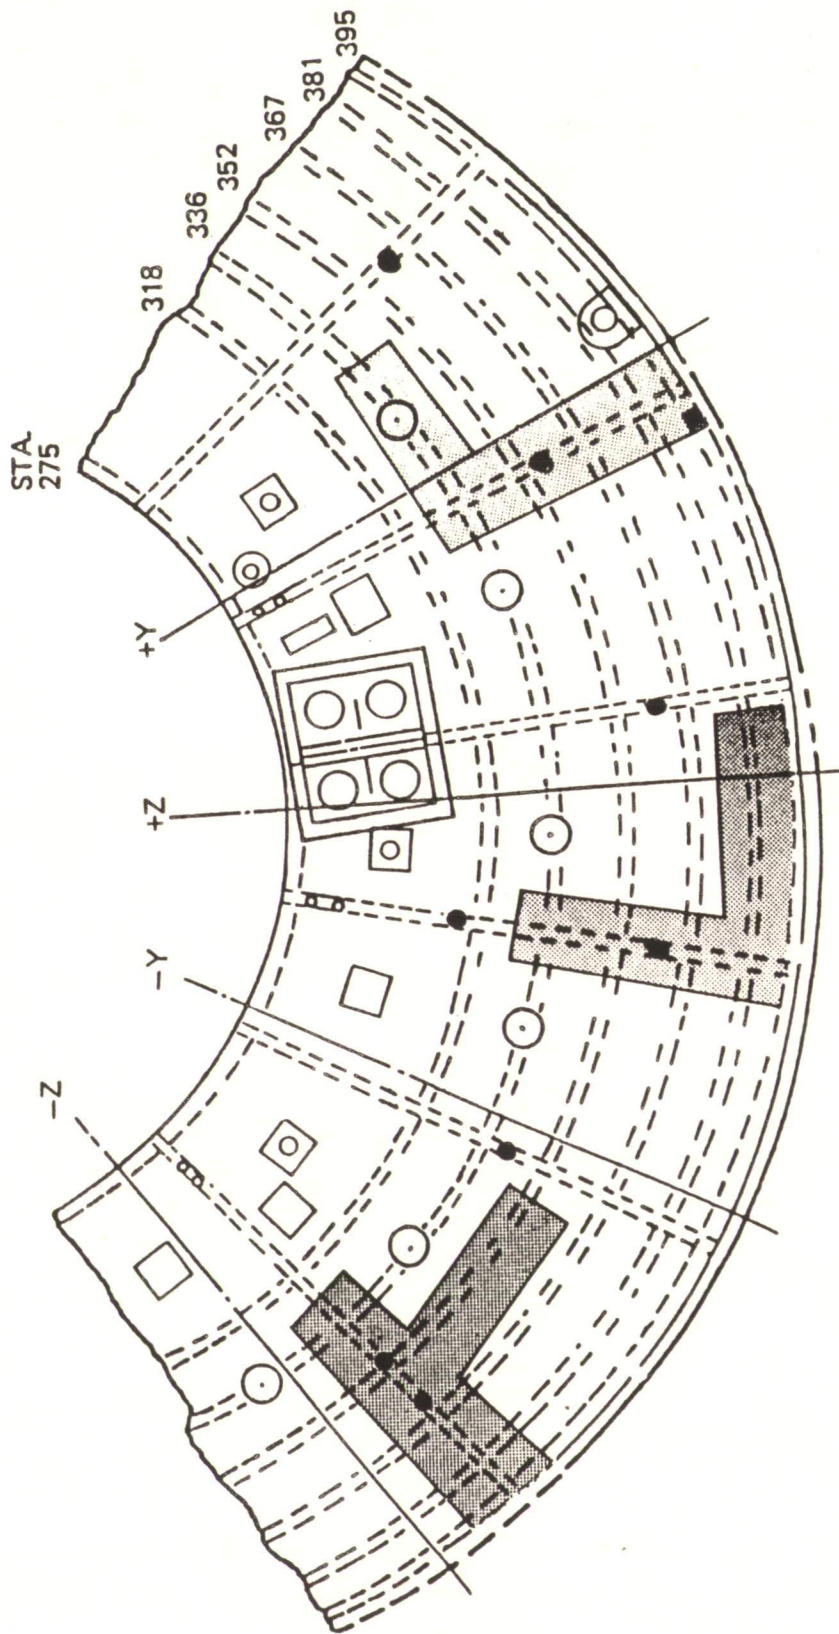
Figure 14. LEFT SRB FRUSTUM

The LH frustum was missing no TPS but had 9 MSA-2 debonds over fasteners. There was minor localized blistering of the Hypalon paint (Figure 14). The BSM aero heatshield covers were locked in the fully opened position.

MISSING TPS
NONE

DEBONDS
● 9

MINOR BLISTERING OF HYPALON
PAINT OCCURRED IN LOCALIZED
AREAS ALONG 395 RING

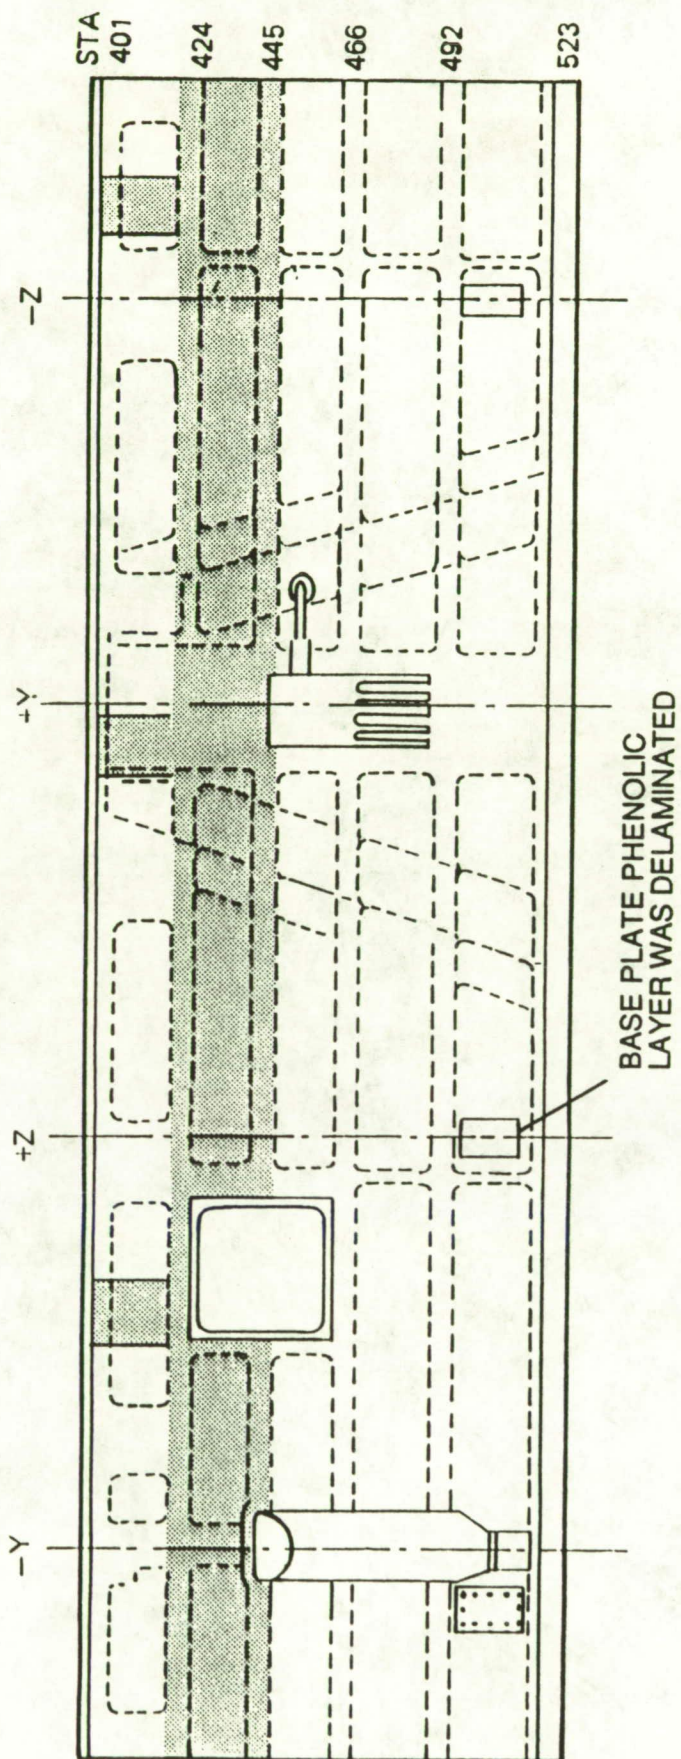
Figure 15. LEFT SRB FWD SKIRT

The LH forward skirt exhibited no debonds or missing TPS. The phenolic plates on both RSS antennae were intact though the material on the +Z antenna plate had delaminated (Figure 15). The forward separation bolt and electrical cables appeared to have separated cleanly. No pins were missing from the frustum severance ring. Minor blistering of the Hypalon paint occurred near the ET/SRB attach point and on the systems tunnel cover.

TPS MISSING
NONE

DEBONDS
NONE

MINOR BLISTERING OF HYPALON
PAINT OCCURRED ON ET/SRB
ATTACH FITTING AND SYSTEM
TUNNEL COVER

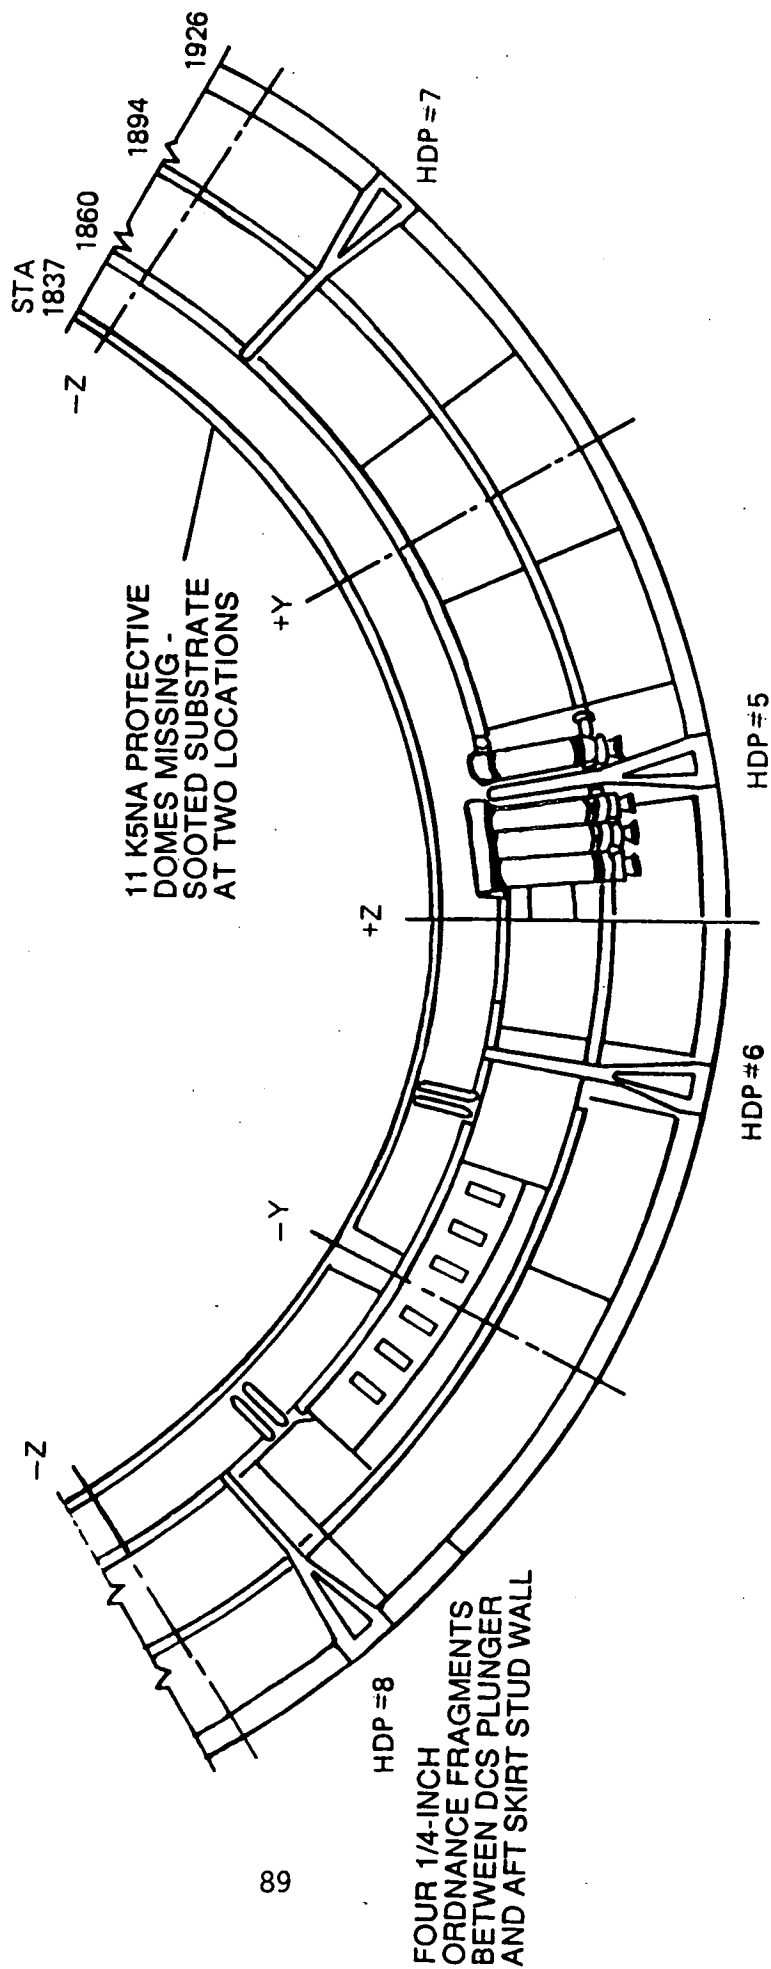
Figure 16. **LEFT SRB AFT SKIRT EXTERIOR TPS**

Two K5NA protective domes were missing from bolt heads on the aft side of the phenolic kick ring prior to water impact (charred substrate). K5NA was missing from all aft BSM nozzles (Figure 16). The aft skirt acreage TPS was in good condition.

ALL DCS PLUNGERS
WERE PROPERLY SEATED

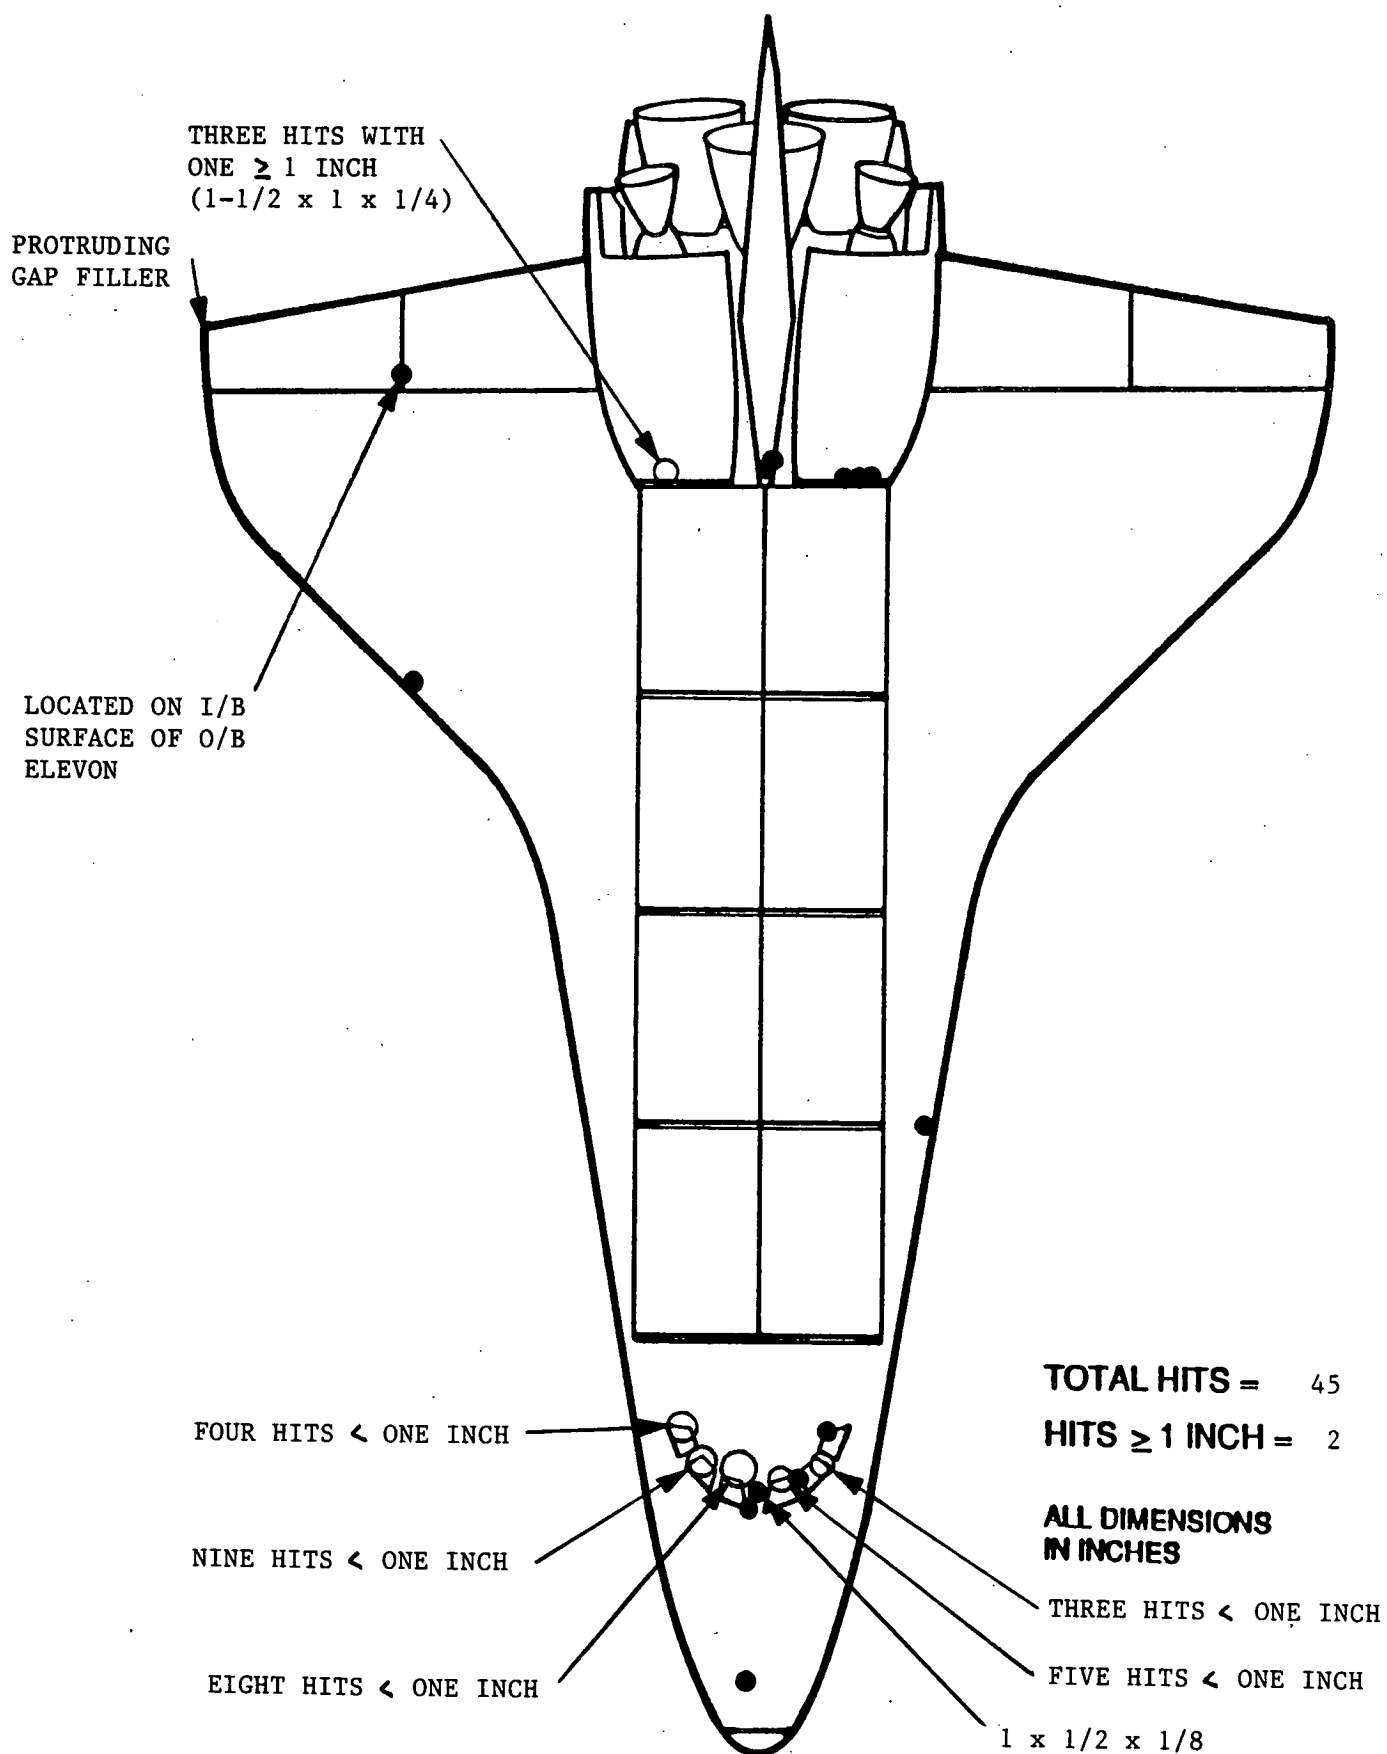
STS-49
Figure 20

A number of damage sites were noted on the perimeter tiles of the Orbiter windows (reference Figure 20). Most of the impact sites were only surface coating losses or were no more than 1/16th inch deep. This damage may have been caused by the RTV used to bond paper covers to the FRCS nozzles or by exhaust products from the SRB booster separation motors.
